ГЛАВА 5.⁵ ВОДОХРАНИЛИЩА И ОКРУЖАЮЩАЯ СРЕДА: ИЗМЕНЕНИЯ ЛАНДШАФТОВ В КАНЕВСКОМ ВОДОХРАНИЛИЩЕ НА РЕКЕ ДНЕПР, УКРАИНА

*DAMS AND ENVIRONMENT: LANDSCAPES CHANGE IN THE KANIV RESERVOIR ON THE
DNIEPER RIVER, UKRAINE*

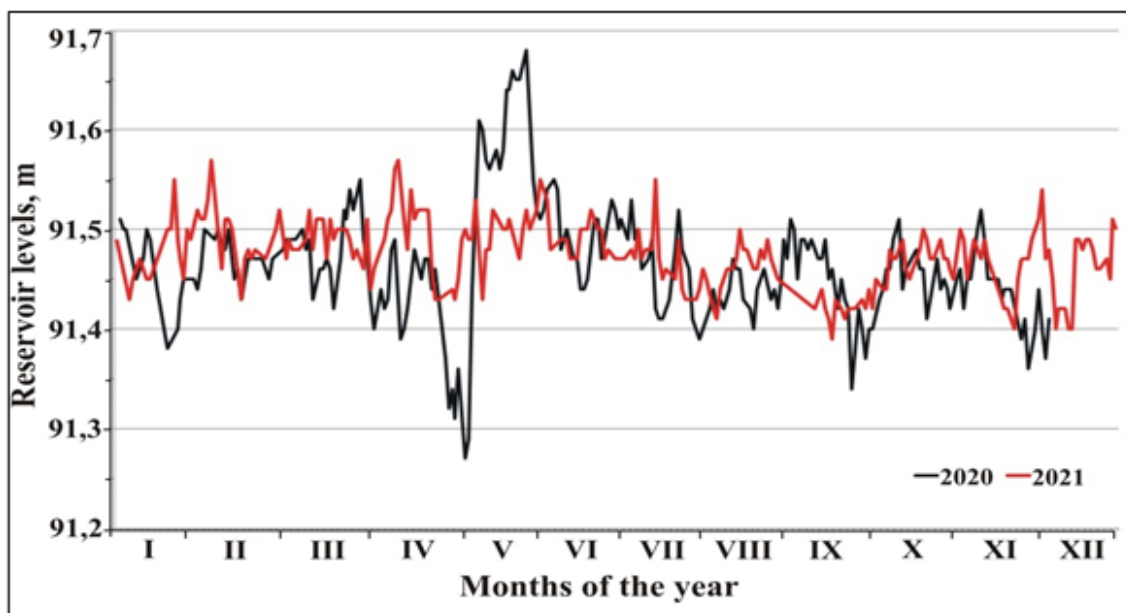
Fig. 3. Fluctuations in reservoir levels in 2020 and 2021

Kaniv Reservoir was filled in 1976 and performs the functions of daily and weekly regulation of the Dnieper runoff to generate electricity mainly during "peak" periods. Thus, its levels fluctuate in a small range of only 20-30cm (Fig. 3). Only in 2010, due to the threat of severe floods [12] and possible flooding of cottages in Koncha-Zaspa, its level was reduced by almost 1 m. The hydro-morphological characteristics of the object change significantly during its operation. In particular, the water surface area [3] and the regulatory capacity of the reservoir decreases due to the accumulation of silt on the bottom, which researchers estimate up to 1 m thick, although the main channel is periodically washed, shallow waters overgrown with macrophytes, island area increases. An important role is played by the hydro-alluvium (dredging) of new lands for country house and cottage development along the left-bank and right-bank dams in the upper part of the reservoir, the area of which we have estimated at more than 1,100 hectares. The formation of hydromorphic landscapes in the reservoir is significantly influenced by geomorphological features of the territory, as both shores of the upper (river) part of the reservoir are lowland, and in the middle and lower (lake) parts the right bank is high and steep (Fig. 4). At the same time, it is in the area of the high right bank that coastal abrasion and erosion occur most strongly, i.e. the banks are transformed (or "reworked" as it is called), and we will discuss this process in detail in Section «**Features of bank transformation in Kaniv Reservoir**».

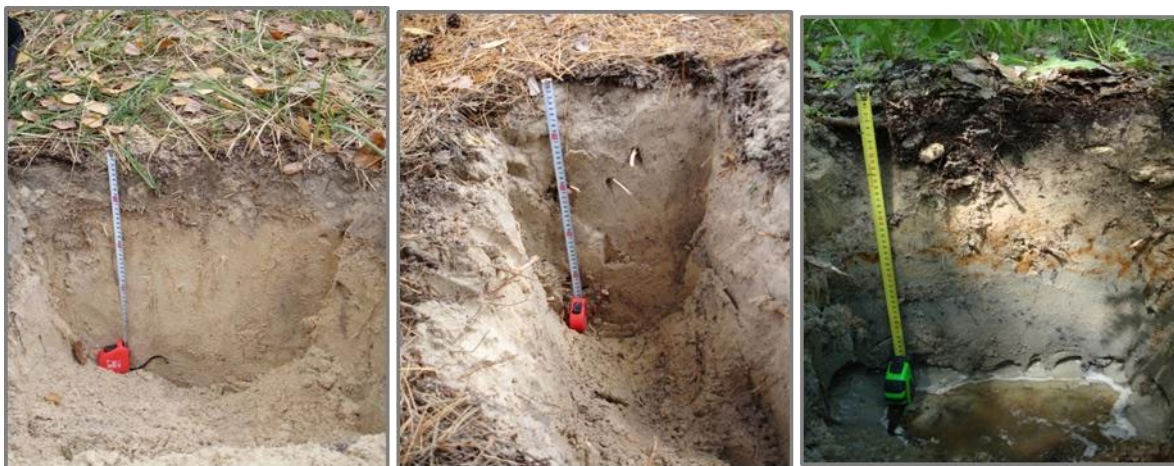
Fig. 6. Soil profiles on the islands of the reservoir: sod (left), soddy-gley(center) and meadow-swamp soils (right)

At the first stage, more attention was paid to the study of hydromorphic soils formed under conditions of waterlogging or periodic flooding on existing and newly formed islands, mainly in the upper part of the reservoir (Fig. 6). Among them, sod soils of various degrees of gleying, as well as meadow, meadow-swamp and swamp soils predominated. It is important to note that the formation of soils as a biotope basis of hydromorphic landscapes occurs differently on the "frontal" (mostly northern) part of the islands and on the rear (mostly southern) part of them according to hydro-morphological features and patterns of litho-morphogenesis. In the first case, sandy or sandy-loam layered alluvium is deposited by currents, which is gradually overgrown by meadow and later by shrub and woody vegetation. Here sod and soddy-gley low-humus soils with weakly differentiated profile are predominantly formed. In the rear part of the islands, where the current is smaller, coastal-aquatic and aquatic vegetation is actively developing in shallow water. Dead organic matter, often with layers of silt, gradually accumulates at the bottom of the shallow water and the soil profile is formed from the bottom up. Swamp and meadow-swamp soils with little decomposed organic matter in the upper horizon are formed.

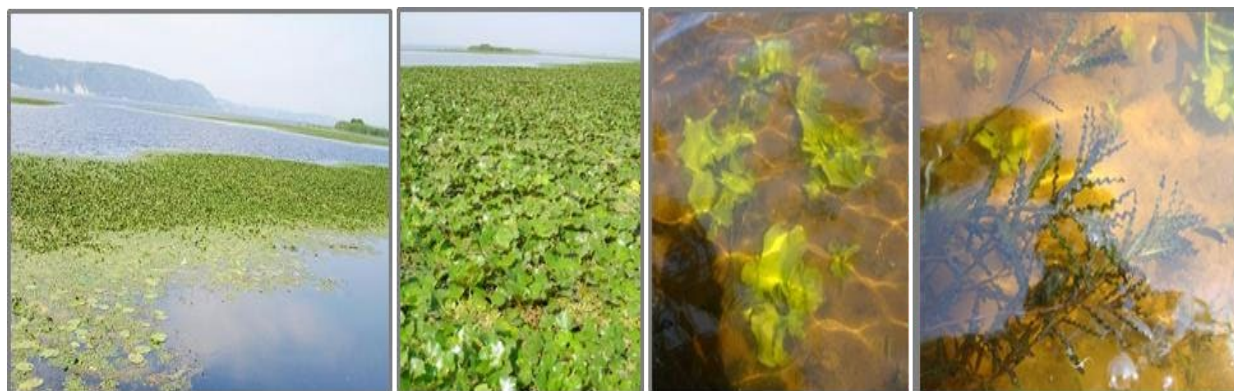
Fig. 7. Aquatic vegetation in the reservoir shallow waters

Coastal-aquatic and aquatic vegetation, its distribution and successions have been studied around the islands and in shallow water, which are more thoroughly described in numerous works of botanists, in particular in publications [6, 7, 15]. As part of the very diverse and well-studied vegetation of the reservoir, attention was paid to the active spread (expansion) in its upper part in the shallows of floating water nut (*Trapanatans L.*) and yellow jugs (*Nuphar lutea*) listed in the Green Book of Ukraine (2009). Shallow waters with coastal-water and shrub-tree vegetation are overgrown rapidly (Figs. 7 and 8).

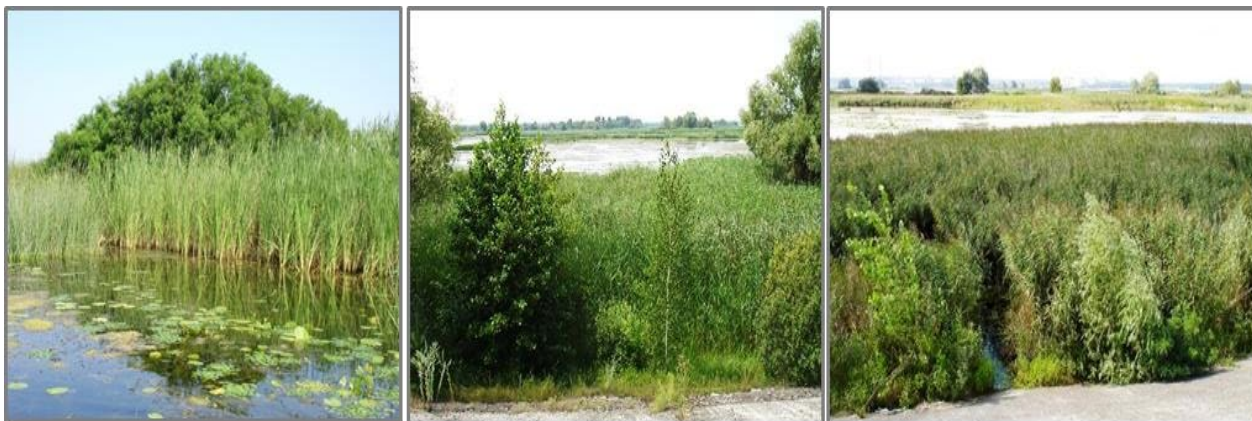
Fig. 8. Overgrowth of shallow waters and islands of the Kaniv Reservoir with coastal-aquatic and terrestrial vegetation

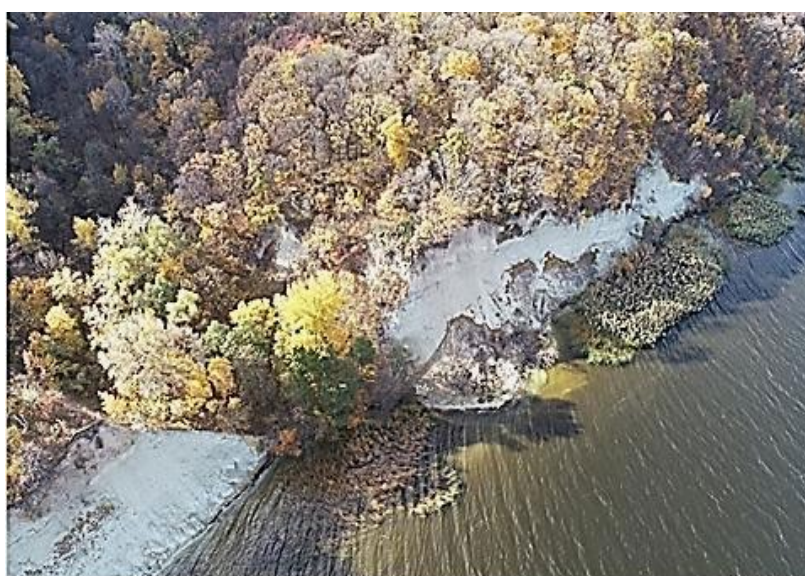
Fig. 10. Fragments of hydromorphic landscapes along the high right bank at the foot of marl cliffs

In the middle part of the reservoir, the formation of hydromorphic landscapes is characteristic of shallow waters with numerous islands, distributed along the coast near the Rzhyschiv military range, where the village of Gusyntsi and its agricultural lands were flooded (Fig. 9). And along the high right bank in the middle and lower (lake-like) parts of the reservoir fragments of hydromorphic landscapes, which we studied using a quadcopter [13], are formed mainly in landslides, talus from high cliffs and outcrops of ravines into the reservoir (Fig. 10).

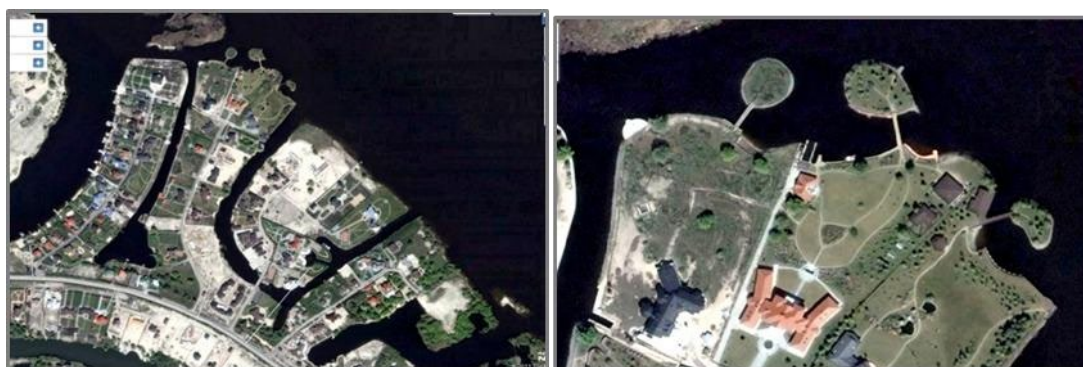
Fig. 11. Non-flowing canals to elite buildings (left) and private islands on hydraulic alluvium lands (right)

In general, the processes of shallow water overgrowth and the formation of new hydromorphic landscapes in the Kaniv Reservoir are influenced primarily by the influx of large amounts of nutrients from the Dnieper and Pripyat Rivers, which accumulates in the Kiev Reservoir, and Desna River water, which is enriched with dissolved organic matter in swamps of their basins. The wastewater of the Bortnychy system, which purifies the waters of the Kyiv metropolis, also plays a significant role in the inflow of nutrients. We should also take into account the role of hydraulic alluvium lands (dredged lands) creation along the right bank with the formation of non-flowing "Venice" canals to elite cottages, clearly visible from space, where the Dnieper water stagnates, pollutes and "blooms" (Fig. 11, 12).

5) The role of non-flowing canals to individual and country buildings on dredged lands in strengthening the "blooming" of water due to the reduction of flow rate and household pollution was detected.

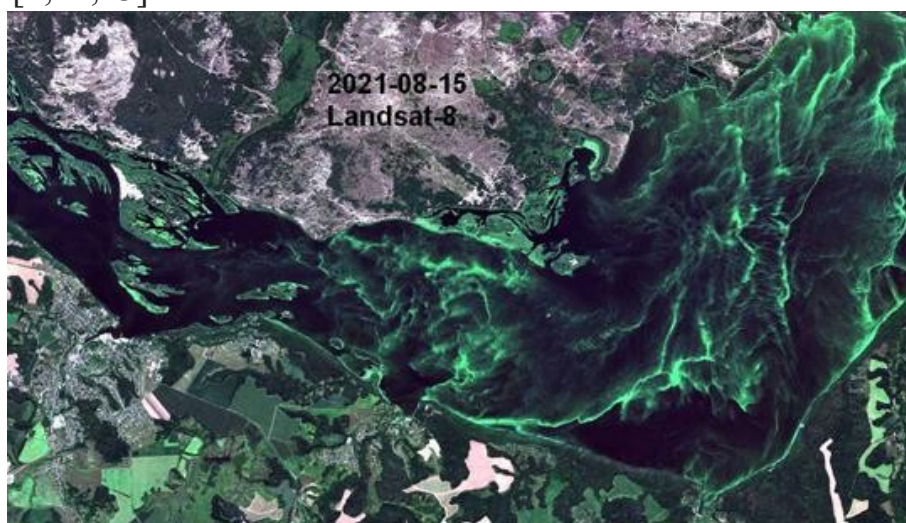
Fig. 12. "Blooming" of water in the middle part of the reservoir (Landsat-8,2021-08-15)

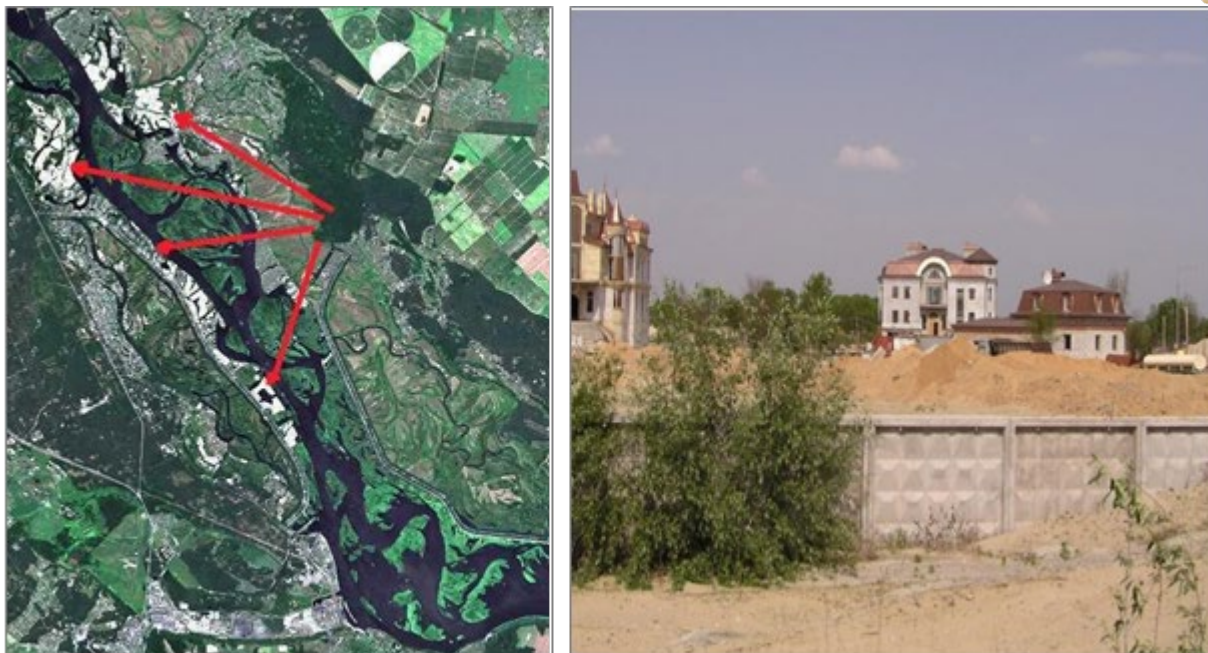
Fig. 17. Hydraulic alluvium of new lands by dredgers in the Kaniv Reservoir: on the left – accumulated (“washed”) areas in the upper part of the reservoir (shown by arrows), on the right - closed access to the reservoir by buildings

Already in 2010, the area of hydraulic alluvium of lands by dredging exceeded 1,100 hectares, much of which has been developed by the owners and is no longer diagnosed in space images. It is extremely important to inform that such construction significantly hinders the possibility of passing extremely high floods in this part of the Dnieper River and threatens flooding and waterlogging of the southern part of Kyiv and adjacent to the reservoir settlements [12]. After our appeal in 2013 to the Ecological Prosecutor's Office of Ukraine with such information, the alluvium of lands within the reservoir water area was stopped for several years. However, in recent years it has been actively renewed (Fig. 17. 18), so this problem needs to be addressed at the state level.

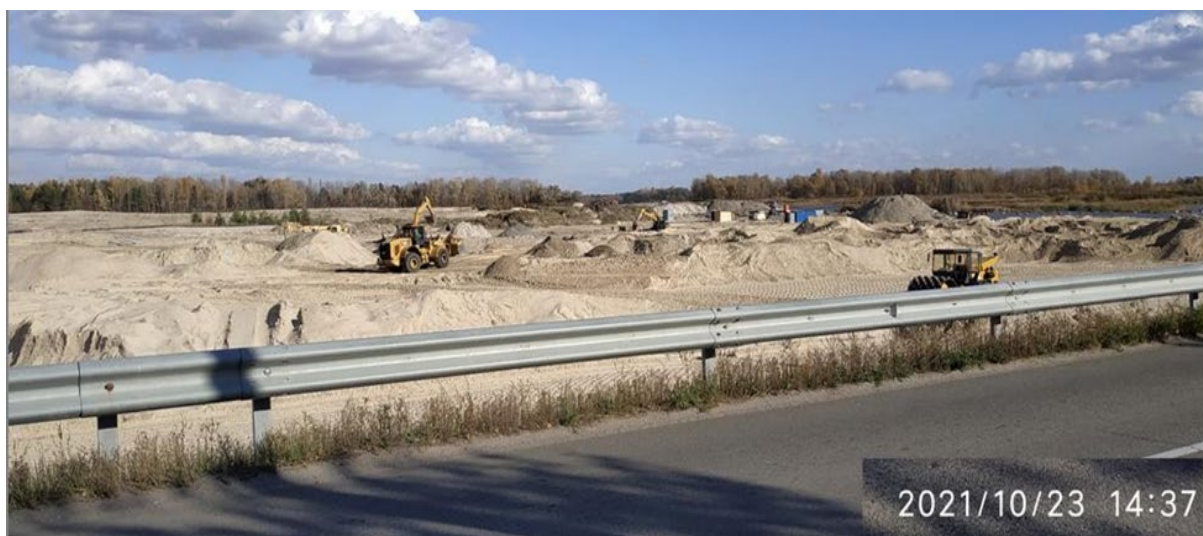
Fig. 18. Active restoration of alluvium lands by dredging and a construction development in the former water areas in 2021

lands within the reservoir water area was stopped for several years. However, in recent years it has been actively renewed (Fig. 17. 18), so this problem needs to be addressed at the state level.

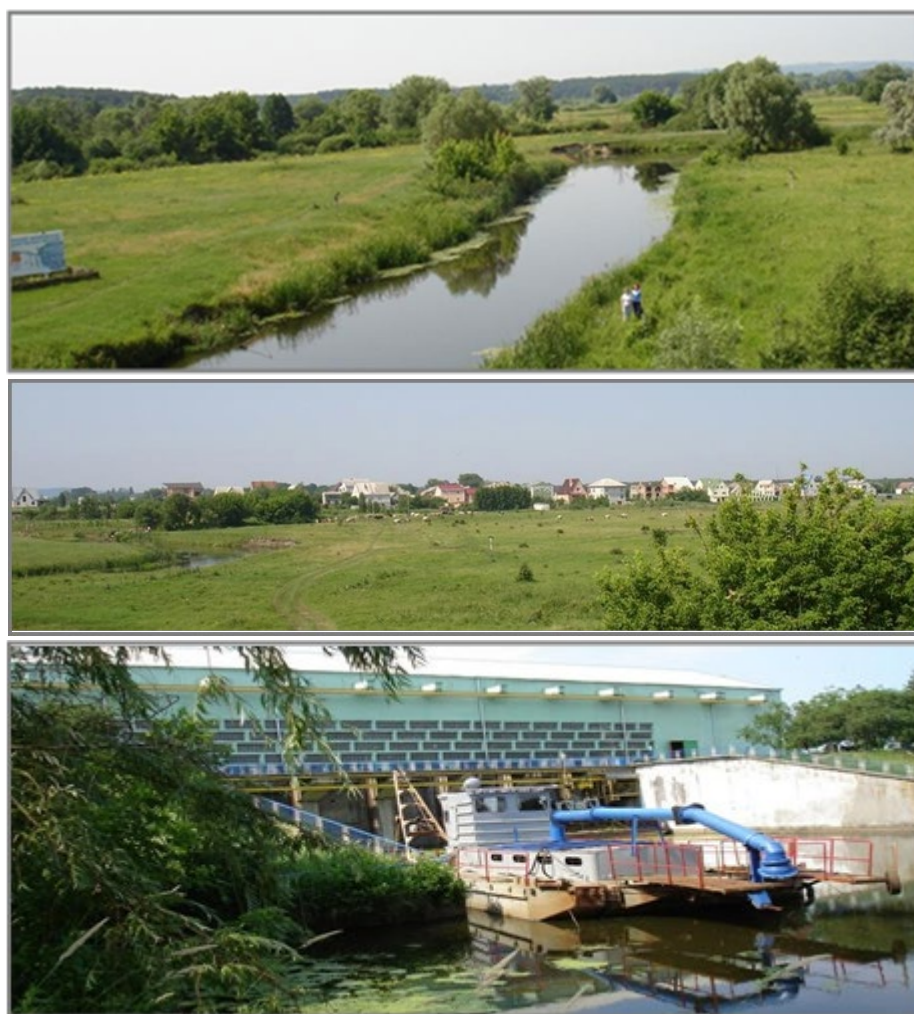
Fig. 19. Protected valley of the Trubizh River (above), cottages in the area of possible flooding (in the middle), Trubizh pumping station (below)

As already mentioned, large-scale (to some extent unique) measures have been taken at the Kaniv Reservoir to engineering the protection of low-lying shores and to create so-called “polder” systems here. Almost 80 km of embankment dams, 7 pumping stations with a capacity of 159.2 m³ / sec, and 75 km of drainage canals were built to protect the coastal soils from inundation and waterlogging. In total, 45.6 thousand hectares of land were protected from flooding, including 25.2 thousand hectares of agricultural land, as well as the city of Pereyaslav (formerly Pereyaslav-Khmelnysky). It should be noted, however, that the operation of pumping stations has become an extremely acute problem in recent decades due to the significant increase in the cost of electricity. Under such conditions, the shutdown of pumping stations will lead to inundation and waterlogging of protected areas, including elite houses and cottages that were built on these lands. A particularly dangerous situation will develop on the western outskirts of Pereyaslav [12]. The massif "Protection of floodplains of the rivers Trubizh and Karan" 45 km long and 4 to 12 km wide is located near the town of Pereyaslav. The area of 30 thousand hectares is protected, including reclaimed lands along the Karan and Trubizh rivers (11 thousand hectares), the outskirts of Pereyaslav, as well as a number of villages along the Karan River. Protection is provided by three dams, a drainage channel and a powerful pumping station. This station, which has 8 pumps, annually pumps 300-400 million m³ of water from the Trubizh River and the drainage canal. To eliminate siltation of the channel near the pumping station, about 10 thousand m³ of sediments are removed annually. Operating costs for these works have increased significantly in recent decades due to rising electricity prices and the cost of the work itself. However, it is not possible to stop pumping river and drainage water into the reservoir, as protected areas will be flooded. This is how a complex engineering decision on land protection has become a burden on the state budget.

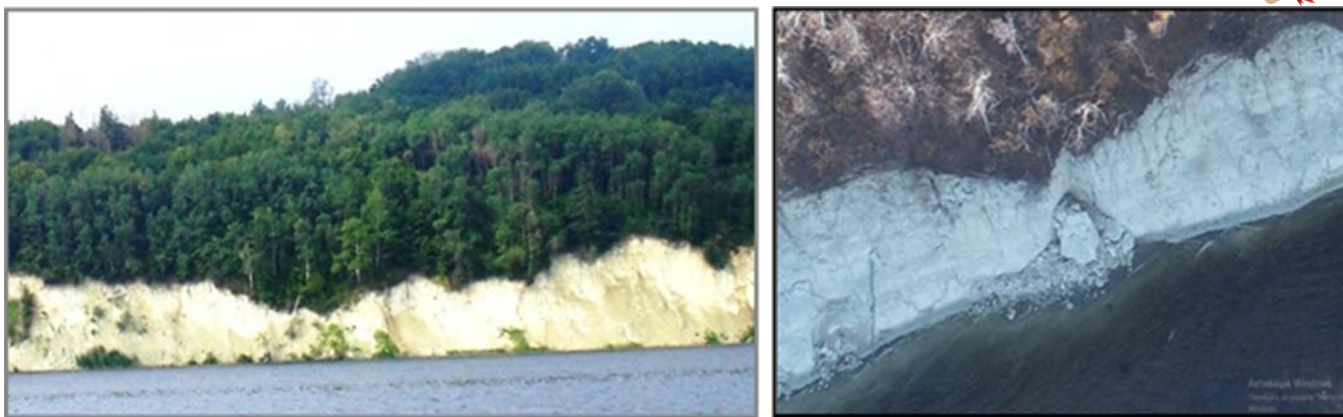
Fig. 20. The shore near the village of Balyko-Shchuchynka (left) and an example of marl clays destruction (right)

of the loess height above the reservoir level is more than 100 m. Shores with cliffs of marl clays stretch (Figs. 20, 21, 25) in a continuous strip from the town of Rzhyshchiv to the village of Khodoriv and continue almost to the Trakhtemyriv village. They are quite resistant to erosion by running water and waves of the reservoir, but still subject to physical and biological weathering in the upper layer (including the roots of woody vegetation). There are collapses of the rock in whole blocks, including trees (Fig. 20).

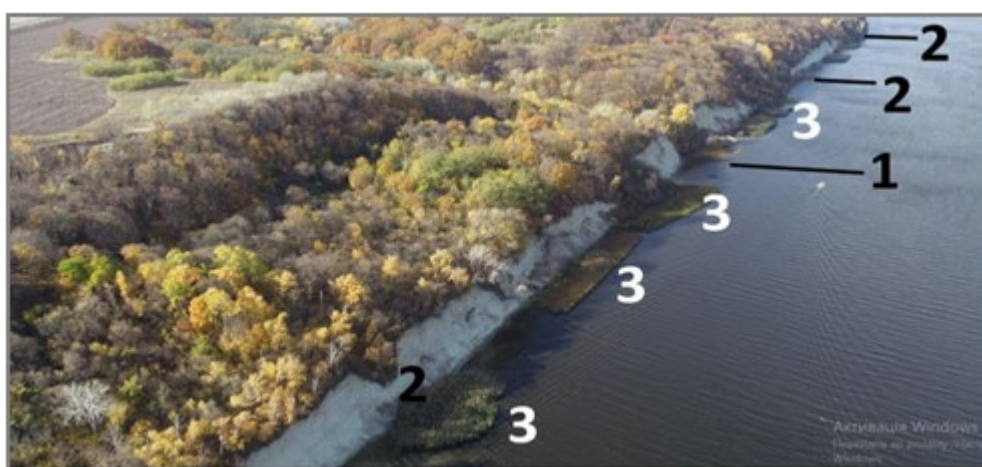
Fig. 21. Transformation of shores by ravines with outputs of marl clays: 1-deep ravine; 2- shallow ravines; 3-fragments of hydromorphic landscapes created by coastal-aquatic and aquatic vegetation on ravine sediments

In general, the transformation of the shores here occurs both under the action of currents and waves of the reservoir, and under the influence of surface runoff, which is concentrated in small and large ravines and destroys marl clays (Fig. 21). Hydromorphic landscapes are formed in fragments at the outlets of ravines [13] during the development of coastal-aquatic and aquatic vegetation on ravine sediments.

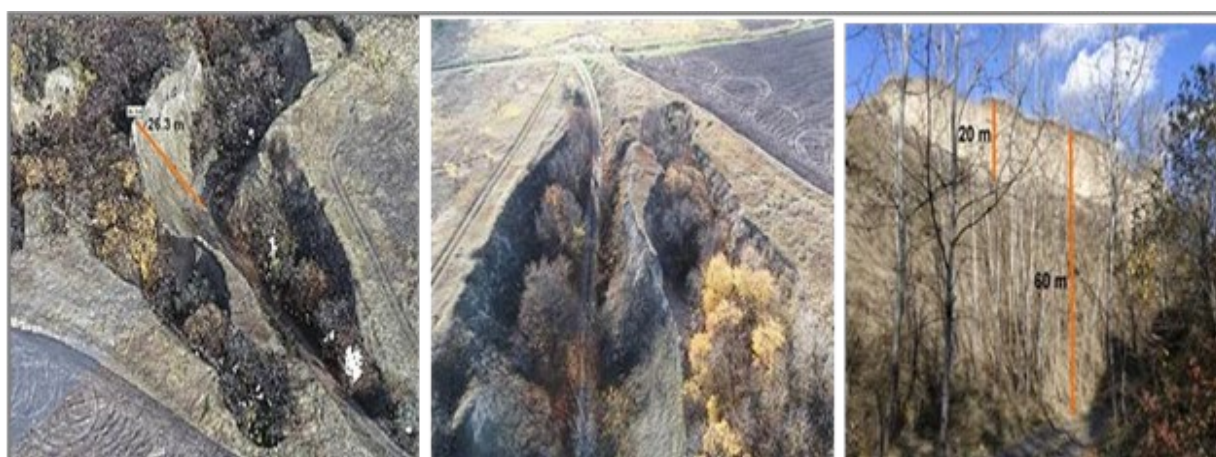
Fig. 24. A deep active ravine north of Rzhyschiv advances on arable land

Actively growing deep ravines remain a great danger for the landscapes of the right bank (Fig. 24). Although they are mostly forested, the lack of earthen ramparts around their tops leads to the ravines advance on arable land and infrastructure.
